**U.S. EPA Community-Wide Brownfields Coalition Assessment Grant
Quarterly Progress Report**

Grantee: Alleghany Highlands Economic Development Corporation
EPA Assessment Grant #BF-96359901-0

Reporting Period: Third Quarter, FFY 2020
April 1, 2020 – June 30, 2020

IRON GATE SCHOOLHOUSE PRELIMINARY ASSESSMENT

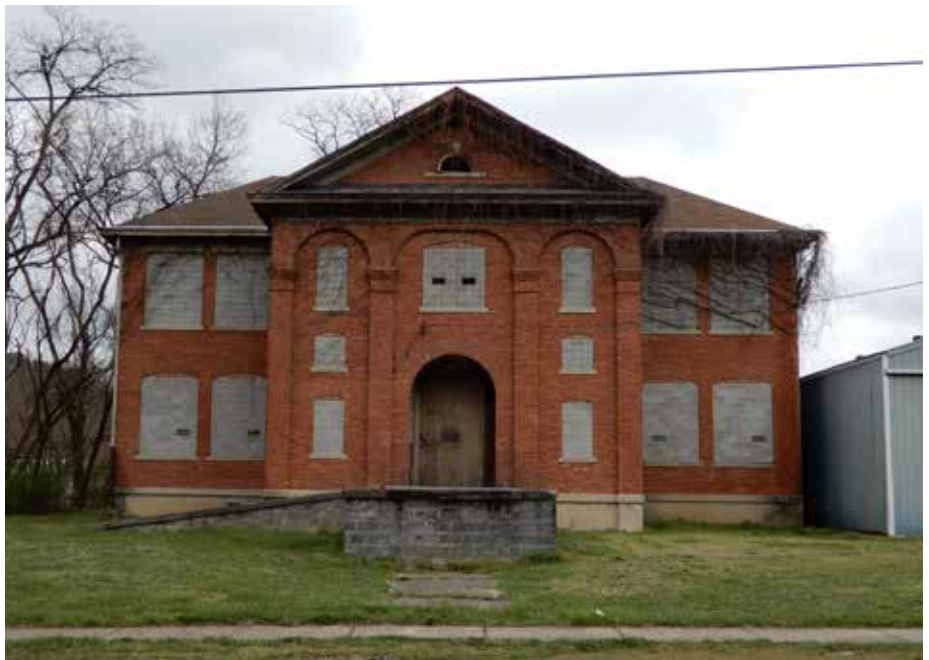
Front elevation showing added loading dock, boarded up front door, blocked windows with small vents and invasive vines in cornice and roof.

- Demolish front loading dock.
- Remove masonry in-fill at windows.
- Renovate building to accommodate new uses. Repair any interior structure. Provide new partitions, ceilings, finishes, flooring where needed. Refinish flooring and repair windows. Provide accessible entrance and second egress stair. Provide all new building systems including electrical, mechanical and plumbing.
- ADA Ramp, parking, utilities to site
- Elevator not required

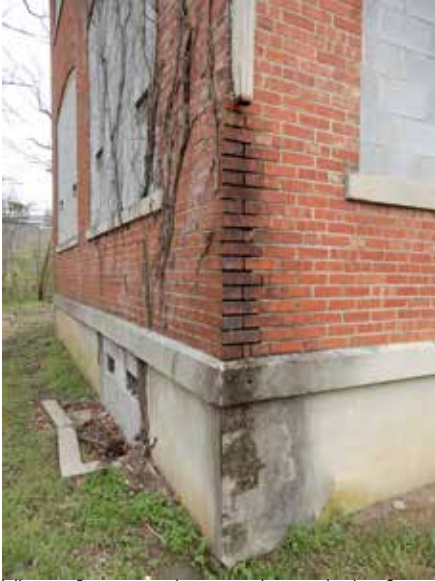
poor condition. The roof over the rear of the build is slate and there appears to be a section on the 7th Street side that is failing. The gutters are in poor condition and the downspouts are either completely missing or the bottom 10' is gone. The lack of downspouts is allowing the roof drainage to erode the mortar in the downspout locations however the rest of the brick appears to be in good condition. No cracks through the face of the masonry were observed. The soffit wood is damaged in several locations and some boards are missing. Invasive vines have grown into the cornice over the years causing deterioration issues.

View of mortar damage due to lack of downspout.

- Repair roof structure, provide new roofing and drainage systems, repair exterior wood and repoint brick, add door to basement.
- Remove freight elevator and damaged plaster, clean out all debris.

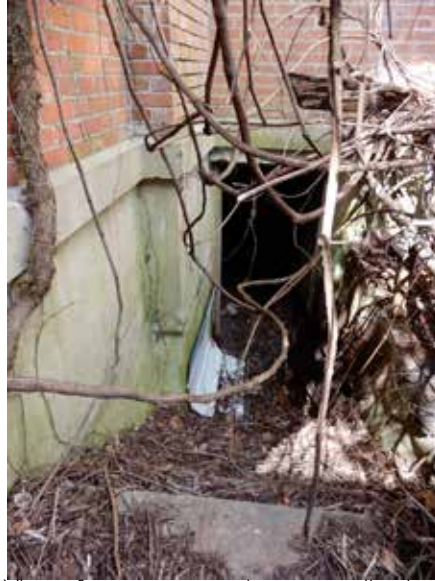
View of open access to basement allowing water and debris infiltration.

The basement is accessed with an exterior concrete stair on the 7th Street side. The door is missing leaving the basement open and the floor is covered with vegetation debris and mud. There is an old boiler and piping in the basement. It appears most of the piping insulation has been removed, but there are a couple of locations where it remains and could contain hazardous materials.

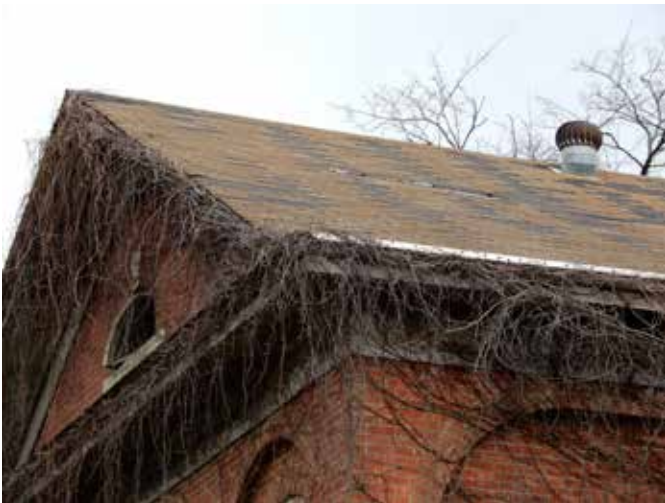
View of deteriorated asphalt shingle roof and invasive vines at roof cornice.

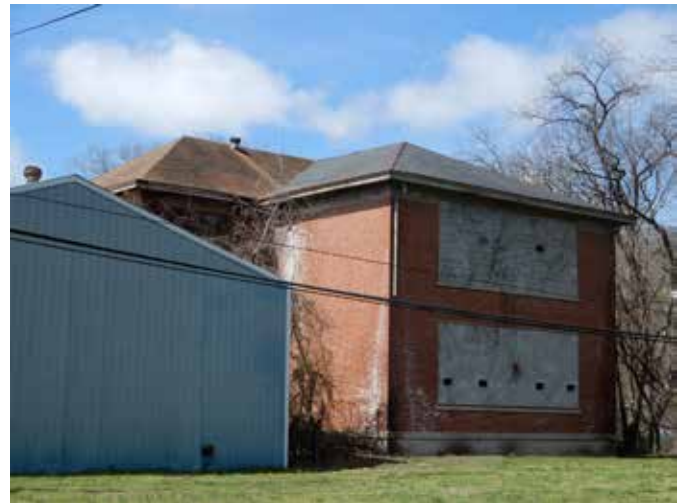
View of rear addition with slate roof and blocked up windows.

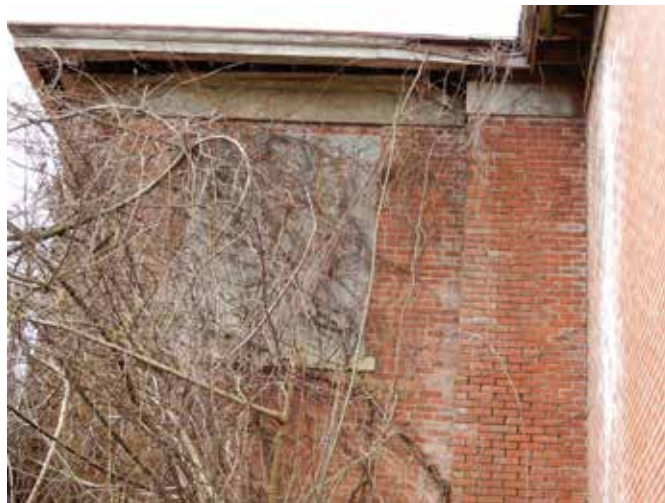
View of deteriorated roof soffit, invasive vines and mortar deterioration due to lack of gutters and downspouts.

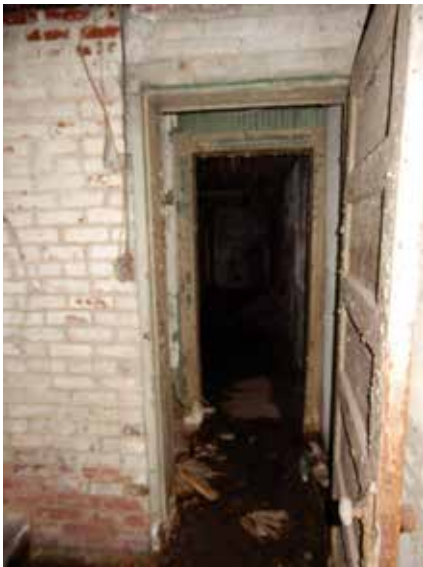
View of basement.

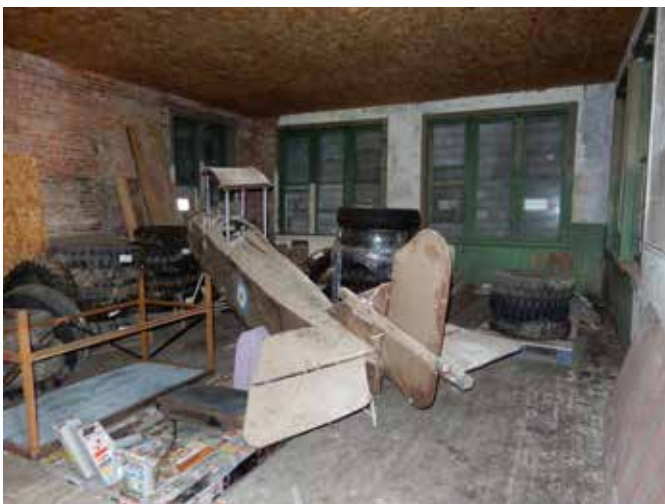
There are no mechanical, electrical or plumbing building systems remaining in the structure. No structural damage such as sagging or bouncy floors, or cracks in the walls was observed. The wood windows are double-hung and appear to be in good condition, with only some broken panes and ropes.

View of classroom showing original windows.

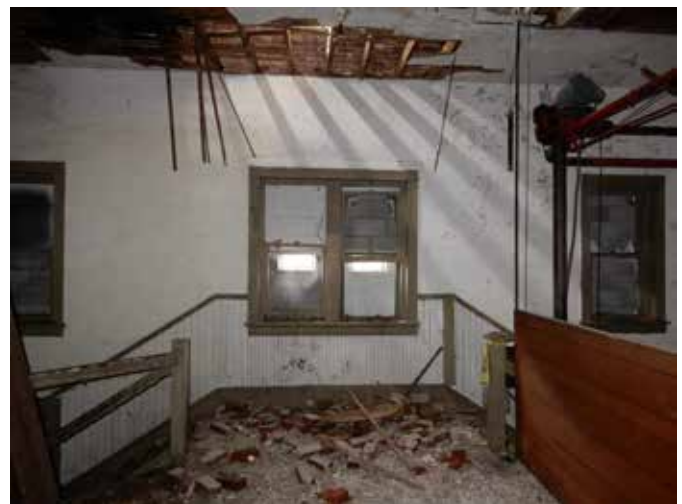
The second floor top of stairs has suffered water damage as the plaster is almost completely collapsed and some brick around the attic vent have fallen out of the wall. The plaster on the walls is in poor condition. The original wood flooring remains but is covered with fallen plaster. The other spaces, corridor walls are missing, have plaster ceilings in poor condition, plaster walls are in fair condition and wood wainscot is in good condition. The original wood flooring is in fair condition. There have been some storage lofts installed in the classroom spaces.

View at top of stairs showing open roof, plaster damage and original windows.
